Seismic Risk Evaluation of Community Mosques in Southern Malang to Assess Their Suitability to Support Disaster Response

Yulia Eka Putrie^{1*}, Luluk Maslucha¹, Aisyah Nur Handryant¹, Sukmayati Rahmah¹,
Viska Ramardhani Akbar¹, Moh. Arsyad Bahar¹, Suci Senjana¹

¹ Department of Architecture, Faculty of Science and Technology, UIN Maulana Malik Ibrahim Malang, Indonesia

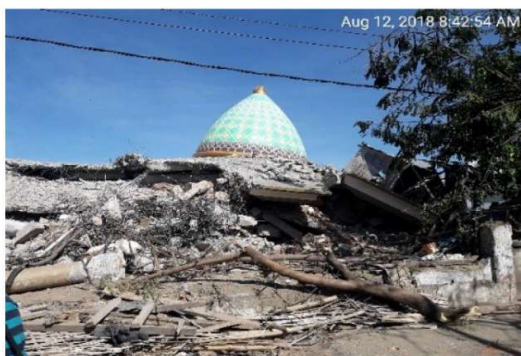
Figure 1 A mosque with severe damage after an earthquake in Lombok, August 2018 [3]

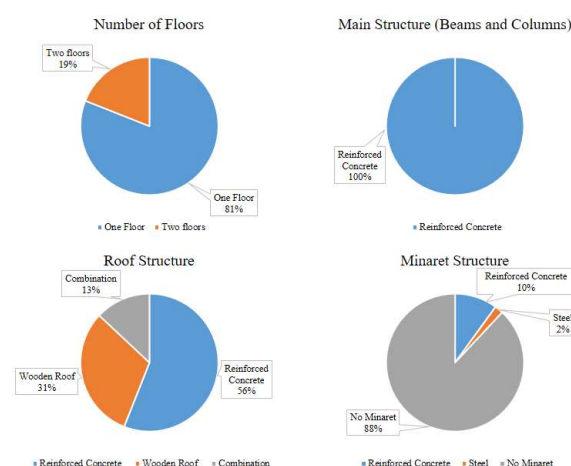
Of the total mosques studied in this research, 81% have one floor and 19% have two floors. All of the mosques studied had reinforced concrete structure as the main structure (beams and columns) of the building (Fig. 2). However, there are variations in the roof structure with 56% using a reinforced concrete roof (flat slab and dome), 31% using a wooden roof structure (*tajug*), and 13% using a combination roof structure of reinforced concrete and wood, or reinforced concrete and steel. Furthermore, 88% do not have minarets, 10% have reinforced concrete towers and 2% have steel towers. Figure 3 summarizes the structural typology of the studied mosques.

Figure 2 The distribution of structural elements of studied mosques

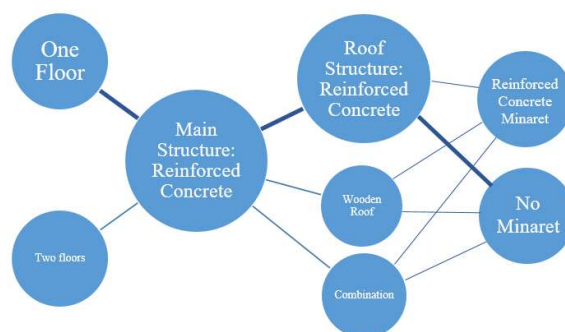
Figure 3 The structural typology of the studied mosques

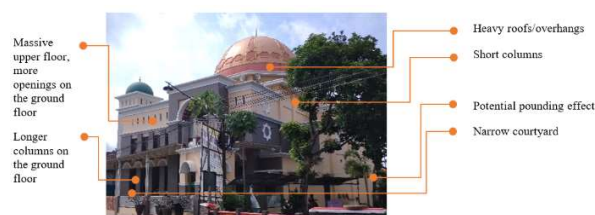
The structural aspects analyzed in this study are (1) potential soft-story, (2) the presence of short columns, (3) the presence of slender columns, (4) the presence of heavy roofs/overhangs, (5) potential pounding effect, (6) the absence/presence of seismic force resisting systems (shear wall, braced frames, or moment frames), and (7) potential topographic effect. Figure 4 is an example of the seismic risk visual screening on one of the studied mosques.

Figure 4 The seismic risk visual screening of a mosque

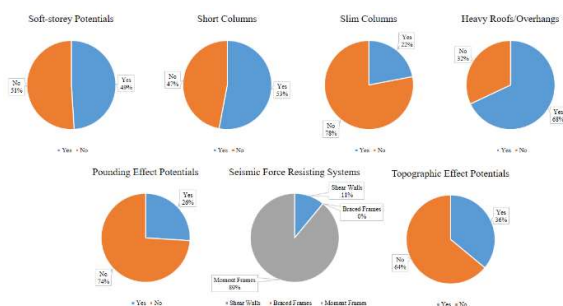
The first structural aspect analyzed is the potential or possibility of a soft-story failure occurring in the mosque building. A soft-story can occur because the stiff and strong upper floors due to masonry infills, the columns in one story longer than the ones above, or discontinuous columns. A soft-story can also occur due to the presence of weak columns and strong beams [11]. Based on our evaluation, 49% of mosques have a soft-story potential. It was a surprise to find some single story mosques (mosques with only one floor) have a soft-story potential due to their multiple flat slab roofs and domes. Of the one story mosques, 38.3% have a soft-story potential. Meanwhile 94.7% of two-story mosques have a soft-story potential because the upper floors and roofs are commonly more massive than those of the ground floor. Figure 5 summarizes the structural aspects of the studied mosques.

Figure 5 Distribution of the structural aspects of the studied mosques

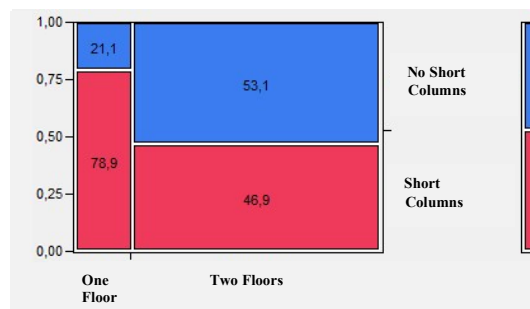
The second aspect analyzed was the existence of short columns. Short columns in buildings can be caused by the presence of mid-story height beams so that some columns become shorter than the others. A ribbon/strip opening at the top of an infill wall in the moment frame structure can also cause short columns [11]. 78.9% of two-story mosques and 46.9% of one-floor mosques have short columns (Fig. 6).

Figure 6 Contingency analysis of short columns by number of floors

In the two-story mosques, the existence of short columns is due to the difference in column height at one series of moment frames on the ground floor or the difference with the column height of the floor above. Meanwhile, in the one-story mosques, most of the short columns are those that support the multilevel flat roofs and domes. There are also short-columns that occur due to the infills and ribbon/strip windows in one and two stories mosques.

3. Masonry infill walls that are too wide without sufficient reinforcement need to be divided with practical columns to stabilize them. Infill walls with strip or ribbon openings along top sides also need to be modified to prevent the presence of short columns.

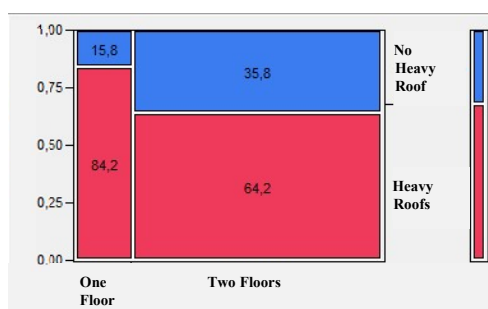
The fourth aspect is the presence of heavy roofs and/or overhangs. 68% of the studied mosques have heavy roofs

and/or overhangs. 84.2% of two-story mosques and 64.2% of one-story mosques have heavy roofs and/or overhangs (Fig. 8). The presence of heavy roofs and/or overhangs in one-story or two-story mosque buildings is due to the large number of concrete slabs (sometimes in two or three tiers) and domes used (Fig. 9).

Figure 8 Contingency analysis of heavy roofs/overhangs by number of floors

5. Lighter upper structures and materials need to be considered whenever a mosque is planned to be significantly renovated. The replacement of heavy concrete domes with more lightweight domes, for example, has been done in many mosques nowadays. Masonry infill walls for the upper floors could also be replaced with perforated walls and mosque ornamentation patterns made of lightweight materials.

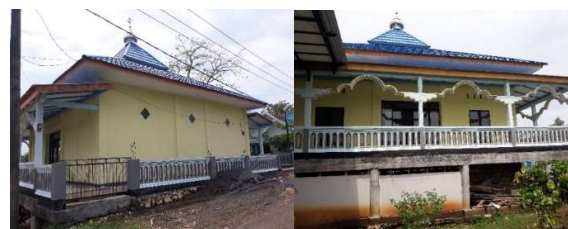
The seventh aspect is the possibility of a potential topographic effect on mosque buildings. A mosque building located on a sloping site has the potential for topographic effect during an earthquake, especially those with a steep slope. 36% of the studied mosques were built on the sloping sites. However, the possibility of a topographic effect during earthquake in several mosques may have been reduced by the presence of retaining walls and efforts to flatten the surface of the sites. Further examination is needed on the quality of the retaining walls, so during an earthquake the retaining walls are strong enough to hold the buildings above.

Figure 11 An example of mosque built on a sloping site with some short columns and discontinuous columns

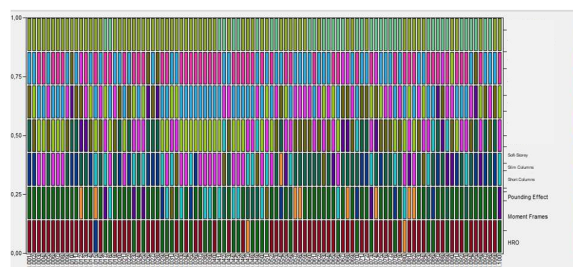
Based on the seven structural aspects analyzed, majority of the studied mosques are gravity-only structures instead of seismic resistant structures. Figure 12 is the result of contingency analysis that summarizes structural aspects of the mosques. In some mosques, the potential for a soft-story is strengthened by the presence of short columns, slender columns, and the heavy roofs/overhangs. However, in the majority of mosques commonly two to three deficiencies were found.

Figure 12. Contingency analysis of mosque codes by various structural aspects

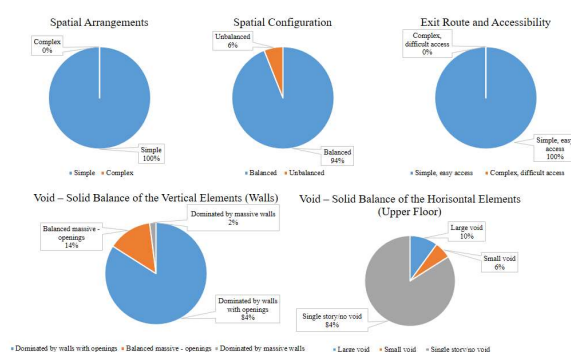
The architectural aspects analyzed in this study are (1) mosques' spatial arrangements, (2) mosques' spatial configurations, (3) void – solid balance of the vertical elements (walls), (4) void – solid balance of the horizontal elements (upper floor), and (5) the building's exit route and accessibility. These architectural aspects may have an impact of some structural considerations, such as the irregularity of columns and beams, or the absence of sufficient seismic force resisting systems due to the openness of building façades. Figure 13 is the result of distribution analysis of architectural aspects of the studied mosques.

Figure 13 Distribution of architectural aspects of studied mosques

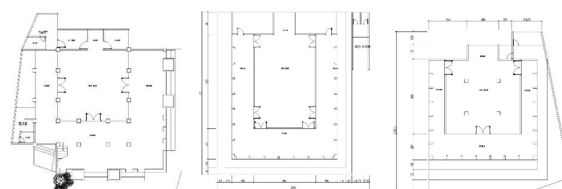
The first architectural aspect analyzed is the connection between the main rooms and the circulation area within the building (spatial arrangements). We investigate whether these rooms are directly connected to the circulation path (hallway, terrace, balcony, or corridor) in a straight or simple way, or are there complex room arrangements (rooms within rooms) before being connected to the main circulation path. Overall, the studied mosques have a simple connection between their rooms and their circulation path. Most of the rooms in the mosques were directly connected to the hallway, terrace, balcony, or an open corridor (Fig. 14).

Figure 14 Some examples of the mosques' floorplan with the simple connection between main rooms and the main hallway

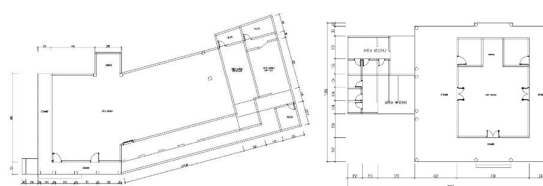
The second aspect is the spatial configuration of the building. This aspect evaluated whether the placement of rooms in the mosques formed a balanced (symmetrical and semi-symmetrical) or unbalanced (asymmetrical) spatial configuration. 94% of mosques have balanced spatial configurations. A balanced or symmetrical spatial configuration would resist horizontal forces in the building without inducing serious torsion effects and simplify the arrangement of the structural elements. However, there are several considerations, such as the shape of the sites and the incremental process of building a mosque, which result in unbalanced spatial configurations (Fig. 15).

Figure 15 Some examples of the mosques' asymmetrical spatial configurations

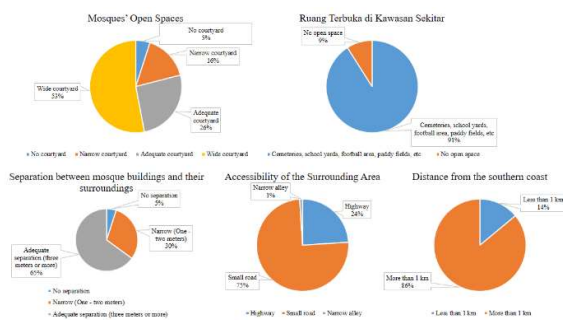
The spatial aspects analyzed in the environment of the mosques are (1) the open space of mosques, (2) the open spaces of surrounding area, (3) the separation of mosques from their surroundings, (4) the accessibility of mosques and surrounding areas, and (5) the distance from the Southern Coast. Figure 18 is the distribution analysis of spatial aspects related to earthquake evacuation.

Figure 18 Distribution of spatial aspects of the studied mosques
